DEPARTMENT OF TRANSPORTATION**DIVISION OF ENGINEERING SERVICES**

Contract #: 04-0120F4Cty: SF/ALA Rte: 80 PM: 13.2/13.9File #: 99.28**WELDING INSPECTION REPORT****Resident Engineer:** Pursell, Gary**Address:** 333 Burma Road**City:** Oakland, CA 94607**Report No:** WIR-002939**Date Inspected:** 06-Jun-2008**Project Name:** SAS Superstructure**OSM Arrival Time:** 2230**Prime Contractor:** American Bridge/Fluor Enterprises, a JV**OSM Departure Time:** 830**Contractor:** Japan Steel Works, Ltd.**Location:** Muroran, Japan**CWI Name:** N/A**CWI Present:** Yes No**Inspected CWI report:** Yes No N/A**Rod Oven in Use:** Yes No N/A**Electrode to specification:** Yes No N/A**Weld Procedures Followed:** Yes No N/A**Qualified Welders:** Yes No N/A**Verified Joint Fit-up:** Yes No N/A**Approved Drawings:** Yes No N/A**Approved WPS:** Yes No N/A**Delayed / Cancelled:** Yes No N/A**Bridge No:** 34-0006**Component:** Tower, Jacking and Deviation Saddles**Summary of Items Observed:**

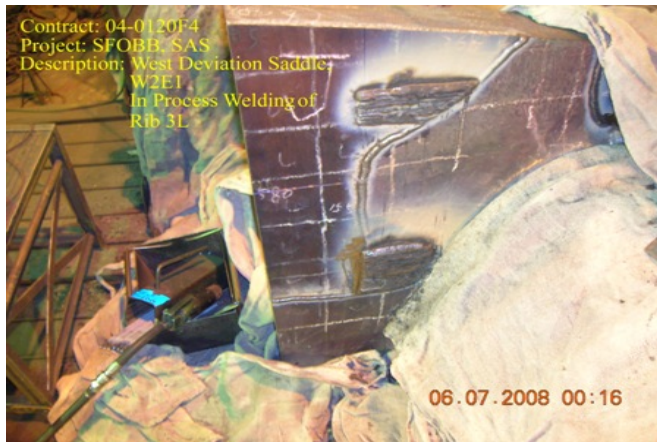
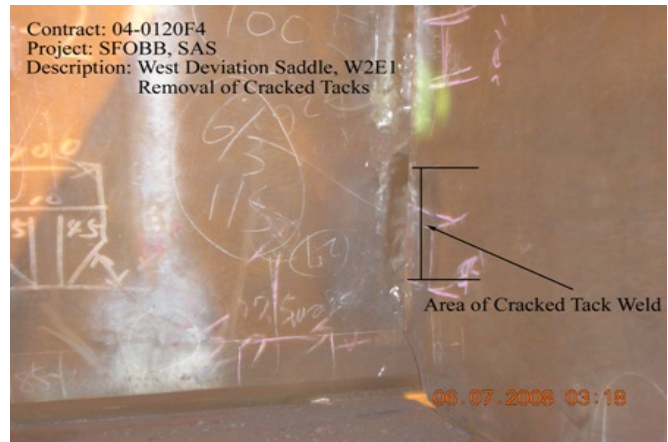
At approximately 22:45 hours the welder completed the repair welding on the rib 2L. Shortly thereafter, the welder relocated to the casting rib identified as 3L and at approximately 23:30 hours the welder commenced the repair welding on the areas identified as 3-4 and 3-5.

At approximately 02:00 hours the QA inspector traveled to the fabrication shop and observed one (1) JSW personnel performing the grinding task on the West Deviation Saddle identified as W2E1. It appeared the grinding was performed on the stem plate to base plate and the rib plate to stem plate connections to remove the existing cracks on the multi-pass tack welds. The removal of the cracked tack welds was not completed during this shift on this date.
